2007 International University Cooperation

Brigham Young University and Universidad Autonoma de Zacatecas

# Runoff Analysis and Culvert Design for “La Presa Bernardez”

Guadalupe, Zacatecas, Mexico

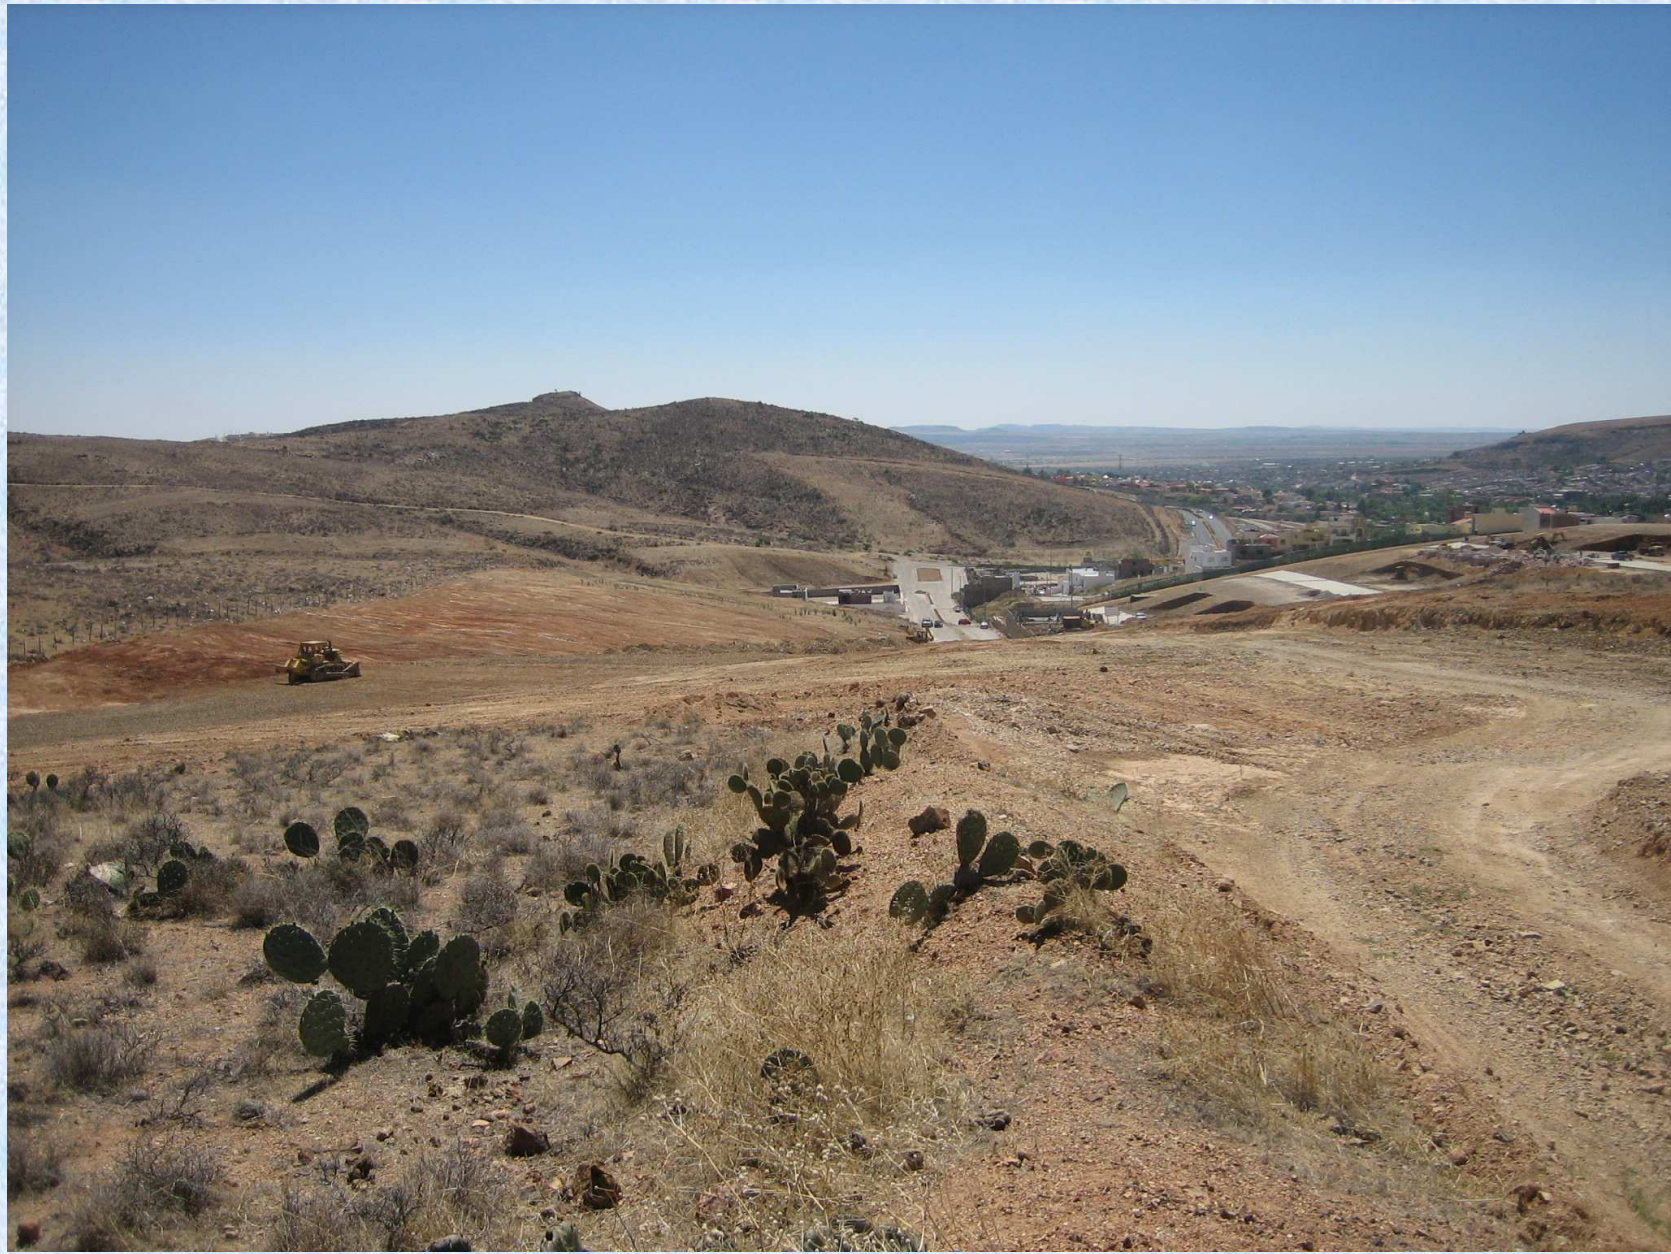
Figure 1. Area of the basin that is undeveloped.

**Location:** The sub-basin Bernardez is located in the developing area between the suburb of Guadalupe and the city of Zacatecas. These cities have populations of 140,000 and 100,000 respectively, are located at an elevation of 7,700 ft, and are located in a high desert climate. The soil is characterized best as desert hardpan and there is little natural ground cover other than coarse grasses, shrubs, and cactus. The basin area is about 500 acres. The three photos below are of the undeveloped ground cover (Figure 1), the developing area (Figure 2), and a developed area (Figure 3) in the basin.

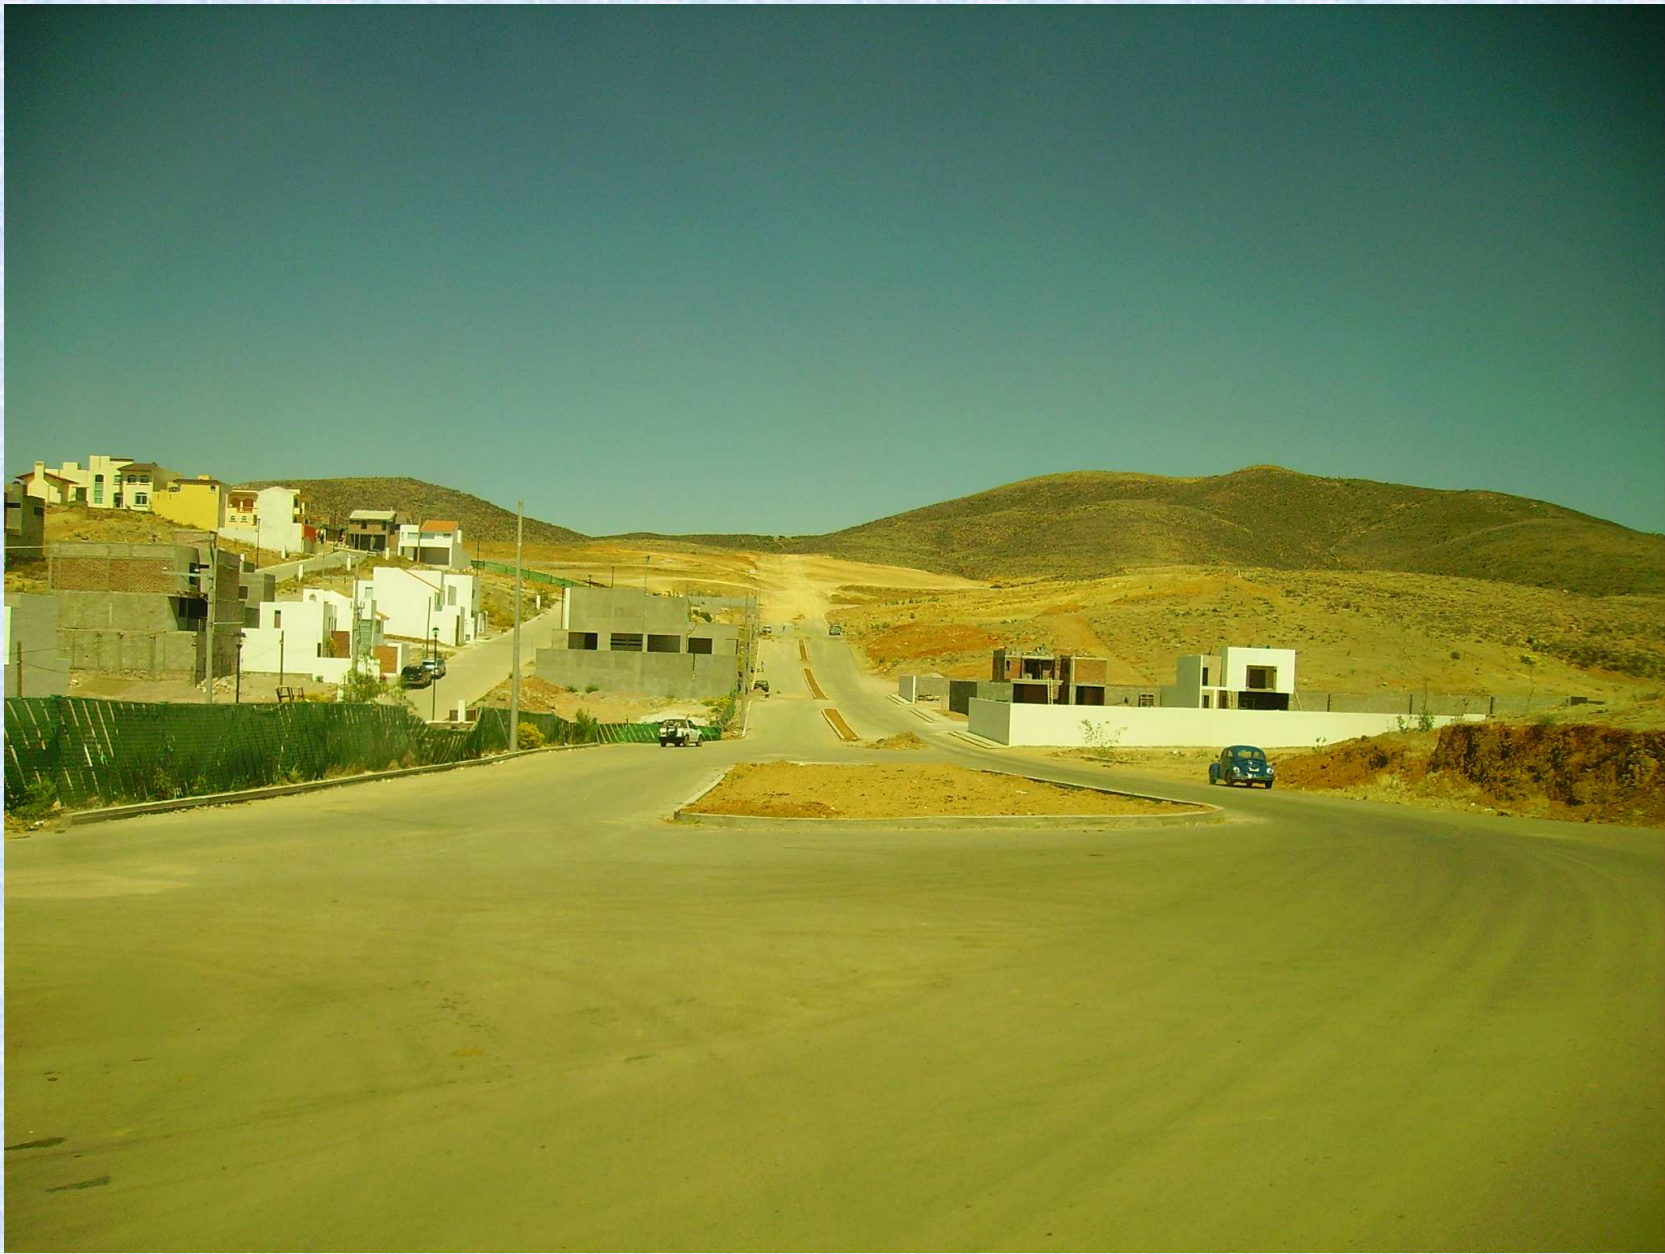
Figure 2. Area of the basin that is being developed.

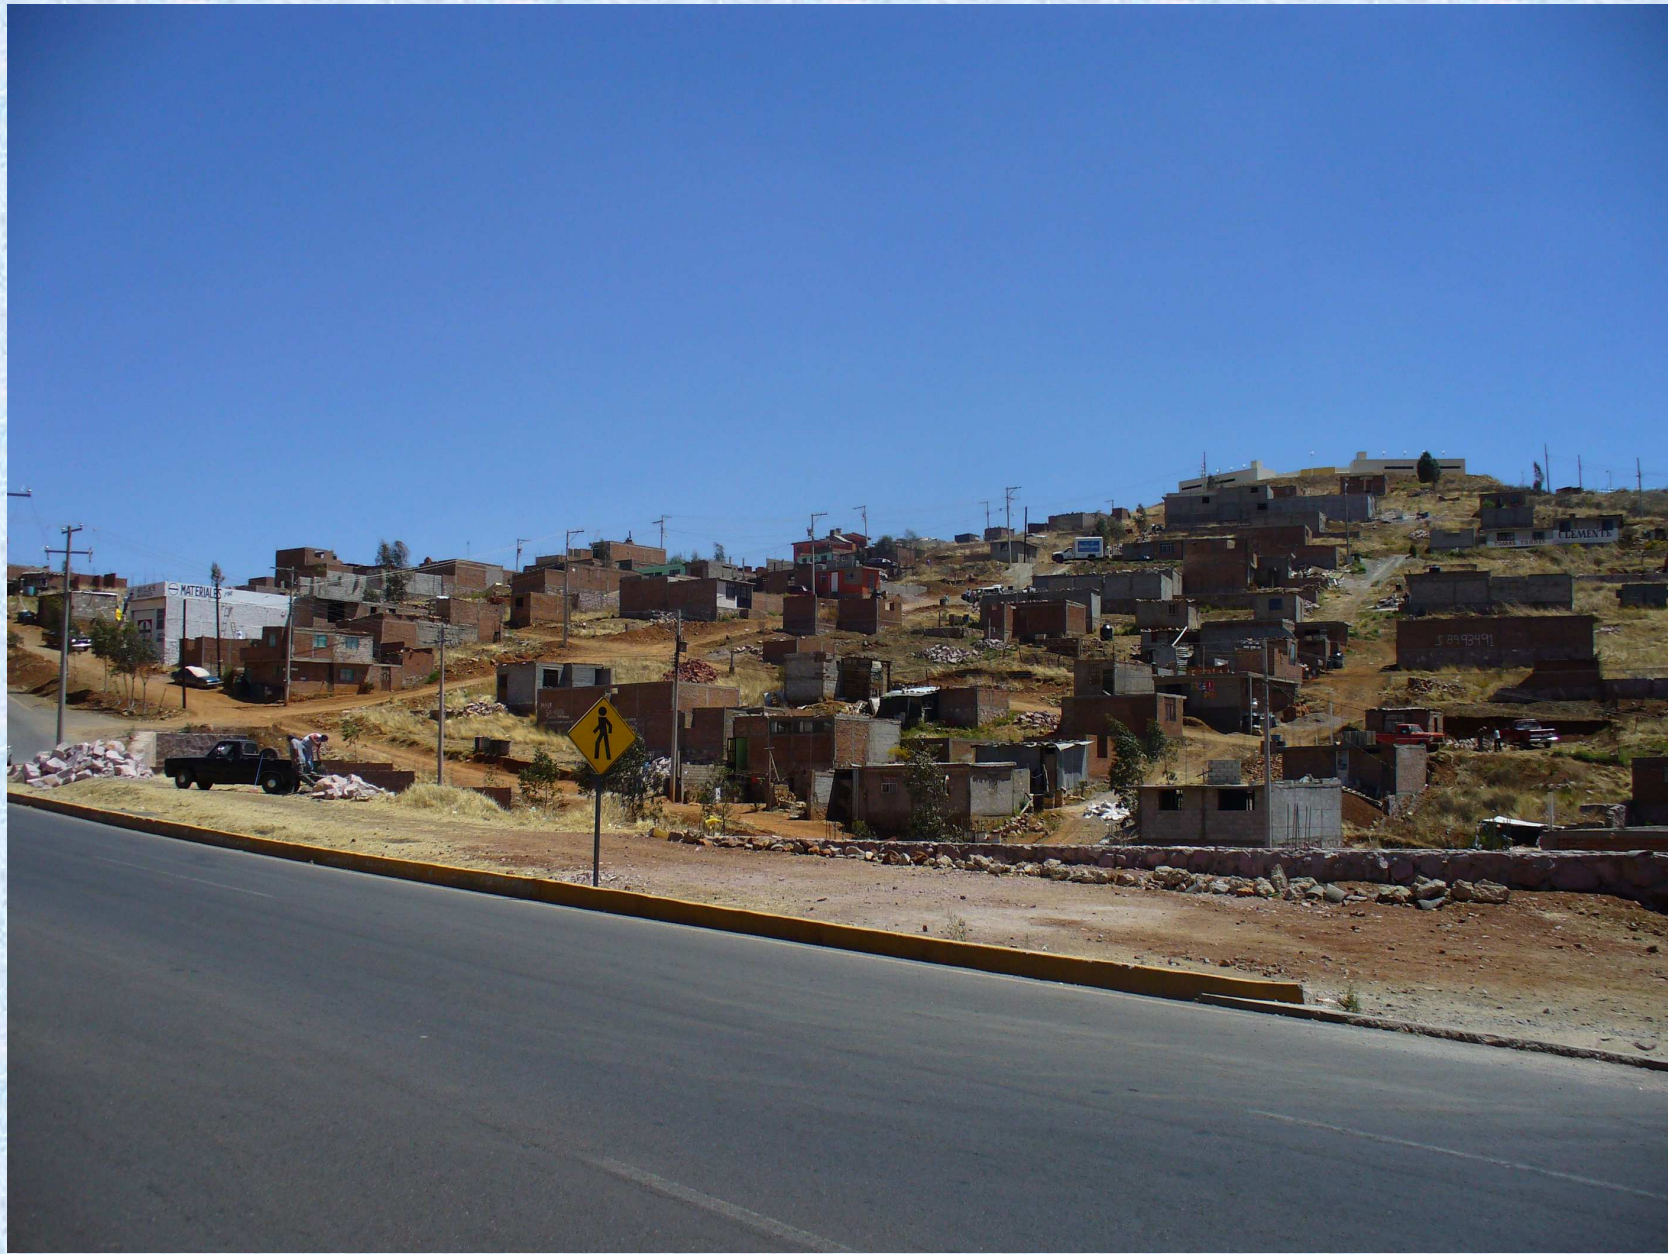
Figure 3. Area of the basin that is already developed.

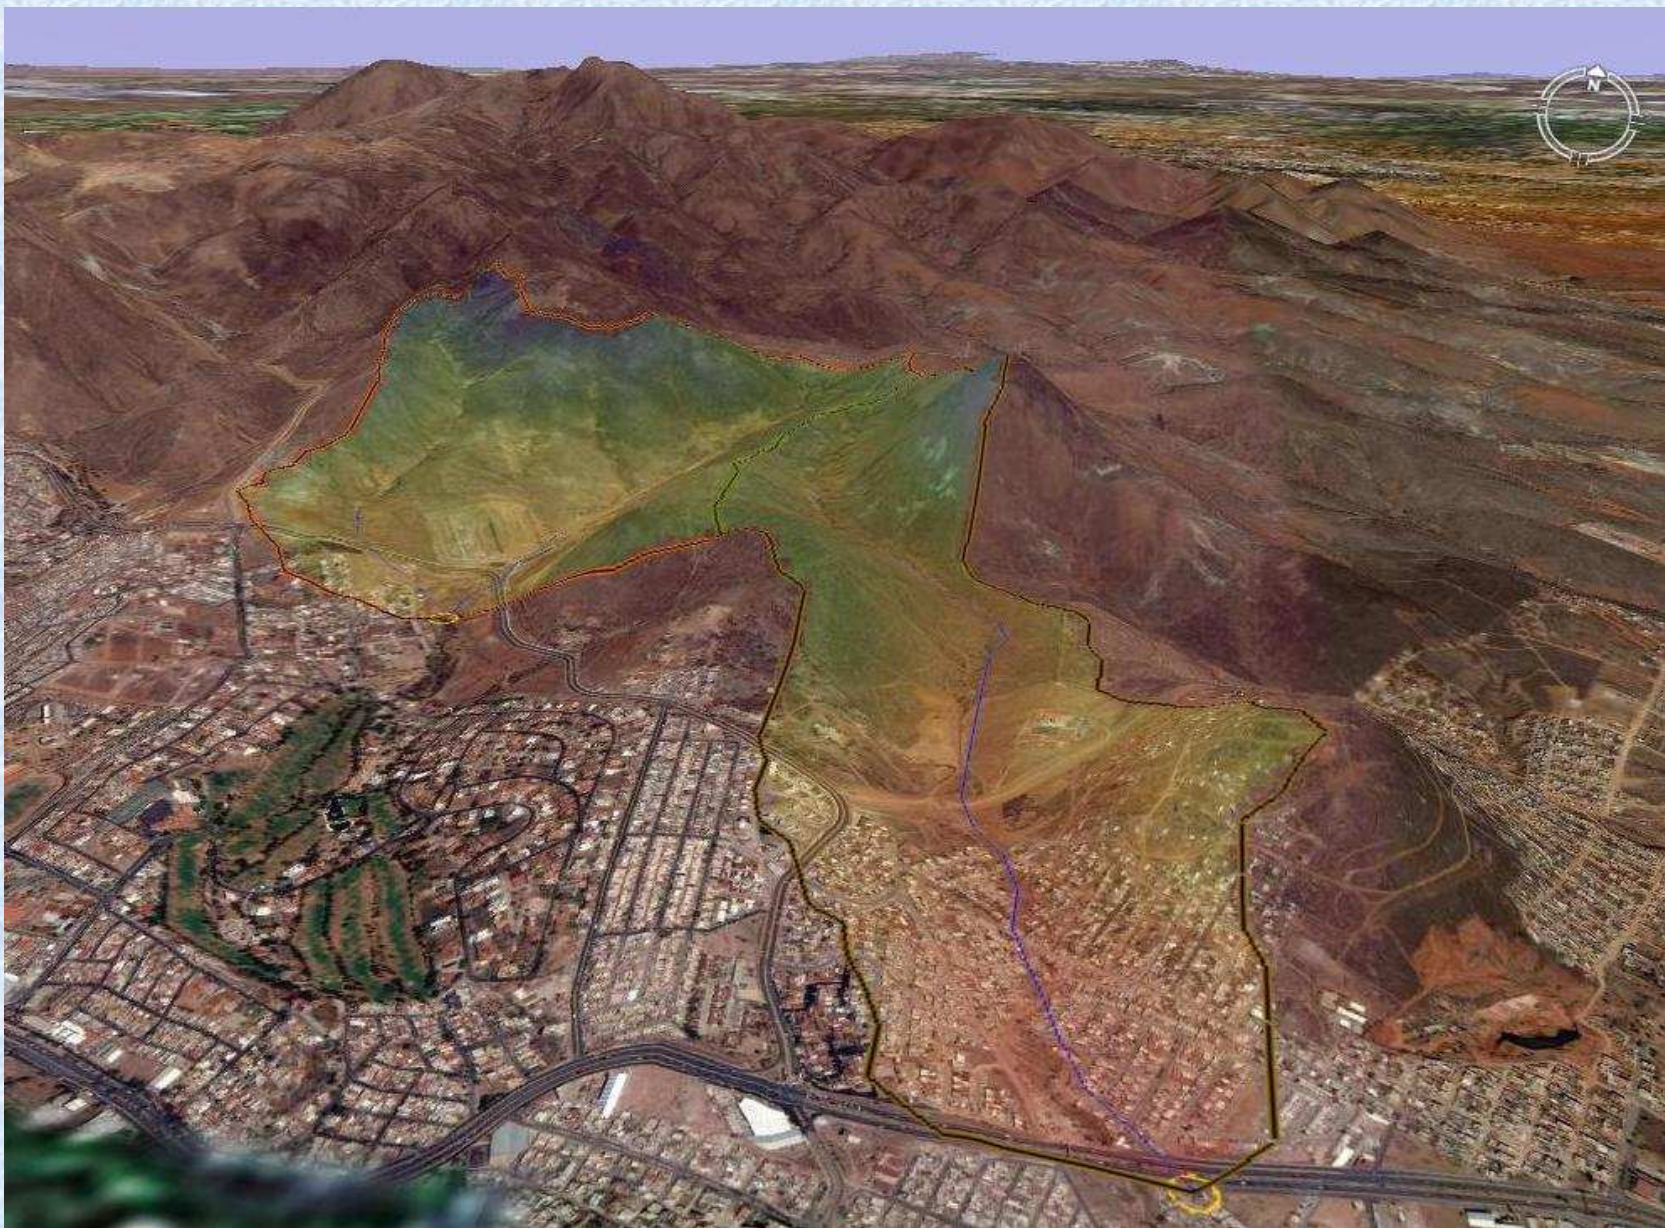
Figure 4. Screenshot of basin.

**Methods:** Watershed Modeling System (WMS) was used to create a digital model of the watershed, combining topographic, precipitation, soil type, natural ground cover, and land use data to perform hydrologic analyses. Figure 4 (to the right) depicts the model as a Google Earth image. The theoretical precipitation used for this analysis was according to the five-year, two- and twenty-four hour historical design storm data, per Zacatecas standards, with an SCS Type-II 24-hour temporal distribution.

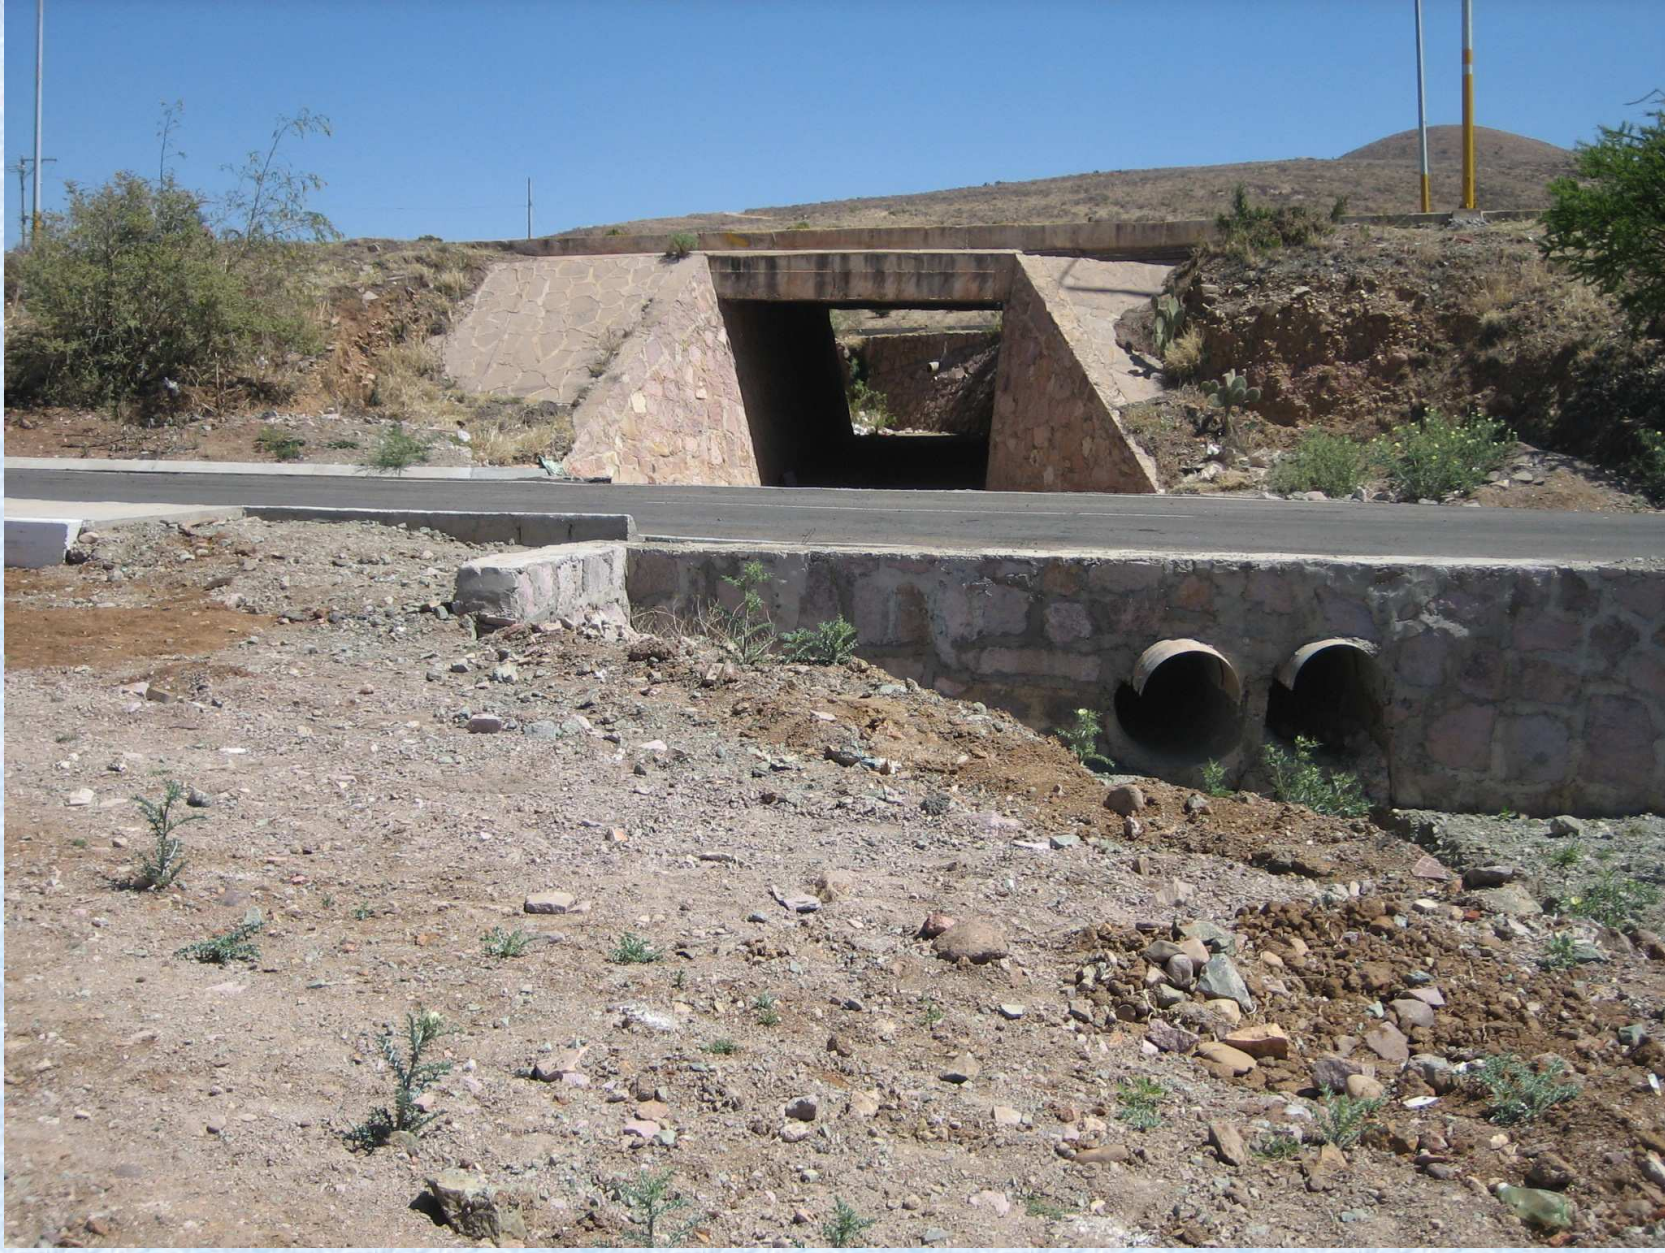
Figure 6. Photo of existing culverts.

**Design :** One of the areas that needs special attention in this basin is a section of road directly upstream of an existing detention basin, as shown in the foreground of Figure 6 (to the right). This road serves as an on-ramp from local streets to the major highway seen in the background. The box culvert beneath the highway is obviously sufficient, but due to the limited size of the double-barrel culvert below, storm runoff consistently overtops the on-ramp, causing hazardous conditions for vehicles as well as potential wash-outs.
